The Role of Hydrogen in the Stress Corrosion Failure of
High Strength Al-Zn-Mg Alloys and Sensitised Austenitic
Stainless Steels.

Annual Technical Report

L. Christodoulou, M.G. Lackey, H.M. Flower, F.J. Humphreys
and P.R. Swann

April, 1980

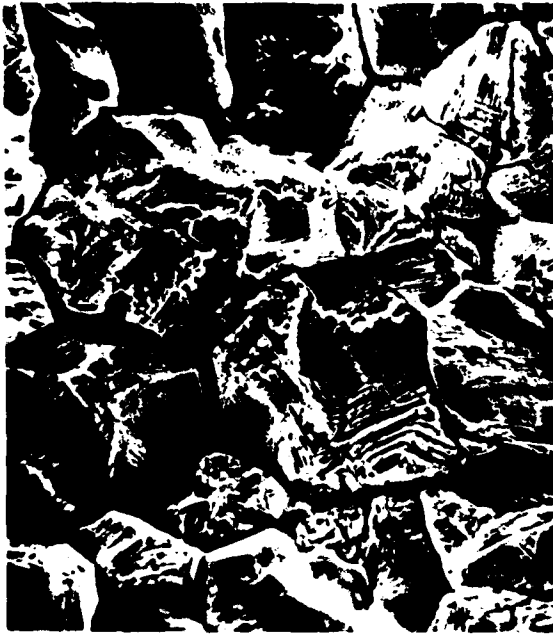
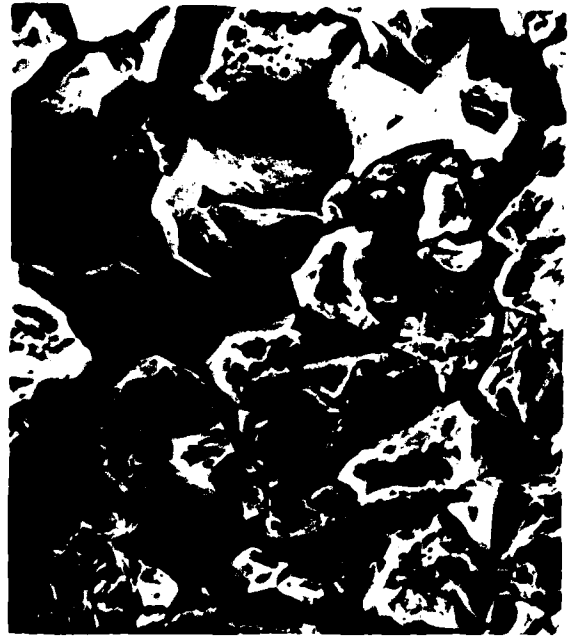
Figure 7. Fractography of SCC

These fractographs are typical of the SCC observed in the more acidic solutions (pH=1, pH=2). Brittle intergranular fracture is depicted in Micrographs A and C, while intergranular tearing predominates in B. Slip line attack and pitting can also be seen in Micrograph C.

In the most acidic environments, the fracture mode was predominantly intergranular. A small area of intergranular tearing was observed where the final failure occurred. Micrographs A and B in Figure 7 are typical of the fracture surfaces in these specimens. The lightly sensitised specimens exhibited some intergranular fracture, but the dominant failure mode was microvoid coalescence (Figure 8).

Although the highly acidic environments did not promote substantial general attack, there was considerable evidence of dissolution on some stress corroded surfaces. Slip line attack and pitting were frequently observed in the pH=1 solutions, as shown in Figure 7. The occurrence of dissolution of the fracture surfaces complicates a valid interpretation of the fractography in terms of a fracture mechanism. As demonstrated previously, the Cr-content of the austenite adjacent to the sensitised grain boundaries can fall below the 12 wt.% necessary for the formation of a passive Cr_2O_3 film. Therefore, it would be expected that after the stress corrosion crack has advanced (by a hydrogen embrittlement and/or anodic dissolution mechanism), the exposed surfaces behind the crack would be readily attacked by the solution. By employing less acidic solutions (pH=2-4), this additional dissolution of the fracture surfaces was reduced considerably.
